Currents in Nassau Harbour **Nassau Harbour Port Improvement Project**

Currents in Nassau Harbour

Nassau Harbour Port Improvement Project

Draft Report

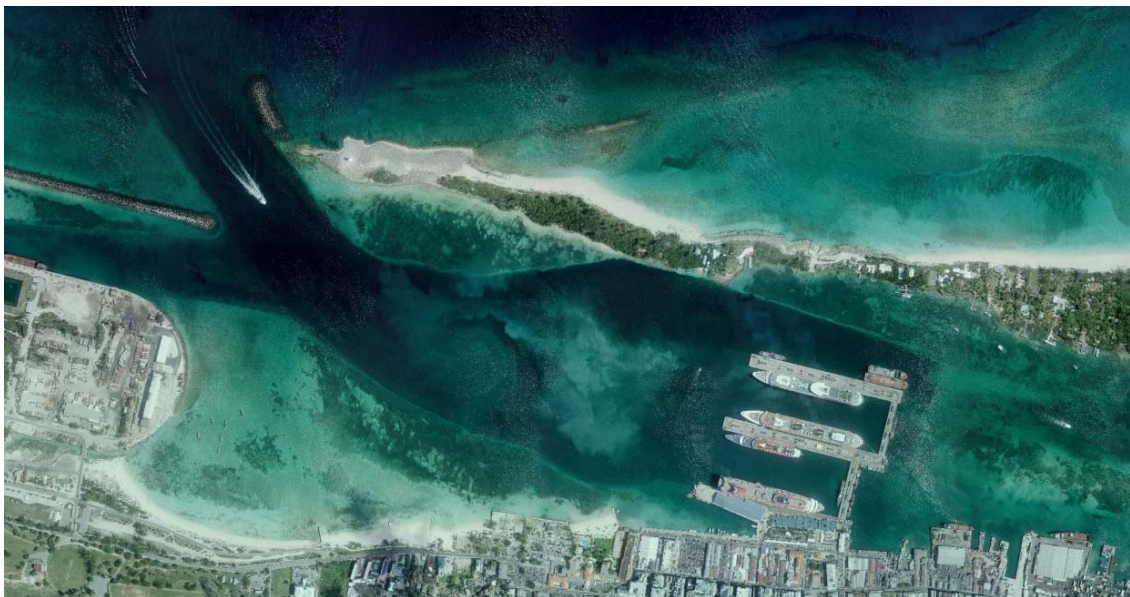
Figure 1.1 Aerial Image of Nassau Harbour Main Navigation Channel

Expansion of Nassau Harbour, shown in Figure 1.1, is planned for 2009, and will involve the widening of the approaches to the harbour and an increase in the size of the turning basin. The dredging that will take place during this operation will result in some turbidity, and there is concern over where this turbidity will spread. In particular, the region to the west of Arawak Cay and the region east of the harbour have been identified as a possible locations where adverse impacts may occur.

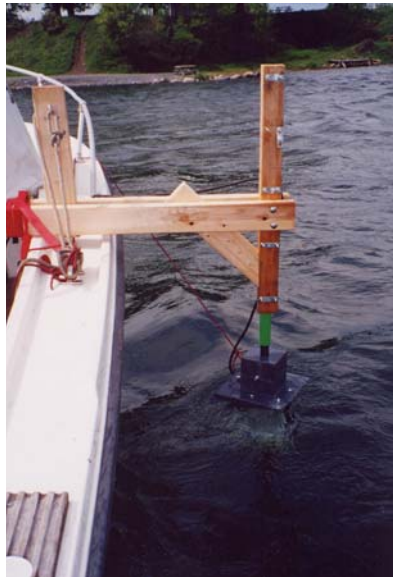
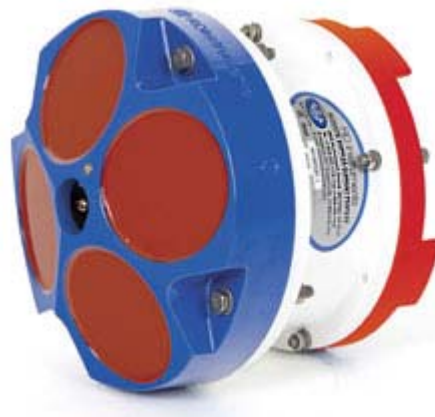
Currents were measured with a RDI Rio Grande 600 kHz Acoustic Doppler Current Profiler (ADCP), which is shown in Figure 2.1. The ADCP uses acoustic pulses from four beams on the instrument to measure the current velocity through the water column. These measurements rely on reflections of the acoustic pulse from tiny particles in the water column. Based on the Doppler shift principle and trigonometric relationships between the beams, the water speed and direction at discrete bins through the water column is computed (relative to the boat). The instrument is also capable of determining the movement of the boat through a bottom-tracking feature, which allows the corrected currents (relative to the bottom) to be computed. As the boat and instrument move across a transect, thousands of readings are collected, resulting in a detailed current profile. In any single “ping” from the instrument there can be considerable error; however, by virtue of the vast number of readings that are collected, the general current patterns are very well represented.

Figure 2.1 ADCP Current Meter

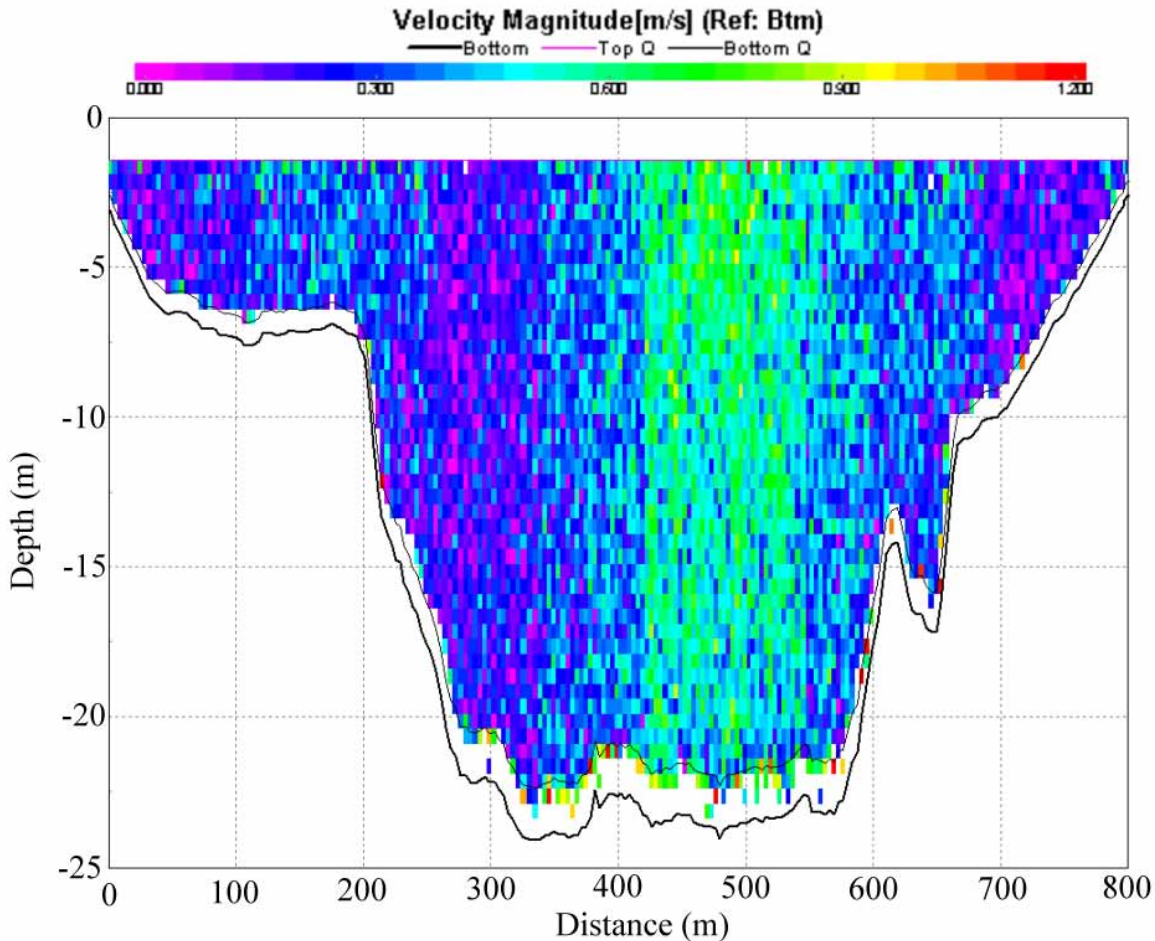
Typical graphical output from an ADCP transect is shown in Figure 2.2. The colours in this figure indicate the current speed at different depths across the transect. Current measurements very close to the bed of the channel and in the top one metre of the water column are not possible. Therefore, the software in the instrument uses a logarithmic relationship to estimate these flow velocities. In addition to measuring the currents along the transect, the instrument also provides an estimate of the total amount of water discharged through the cross section.

Figure 2.2 Typical Output from the ADCP Instrument

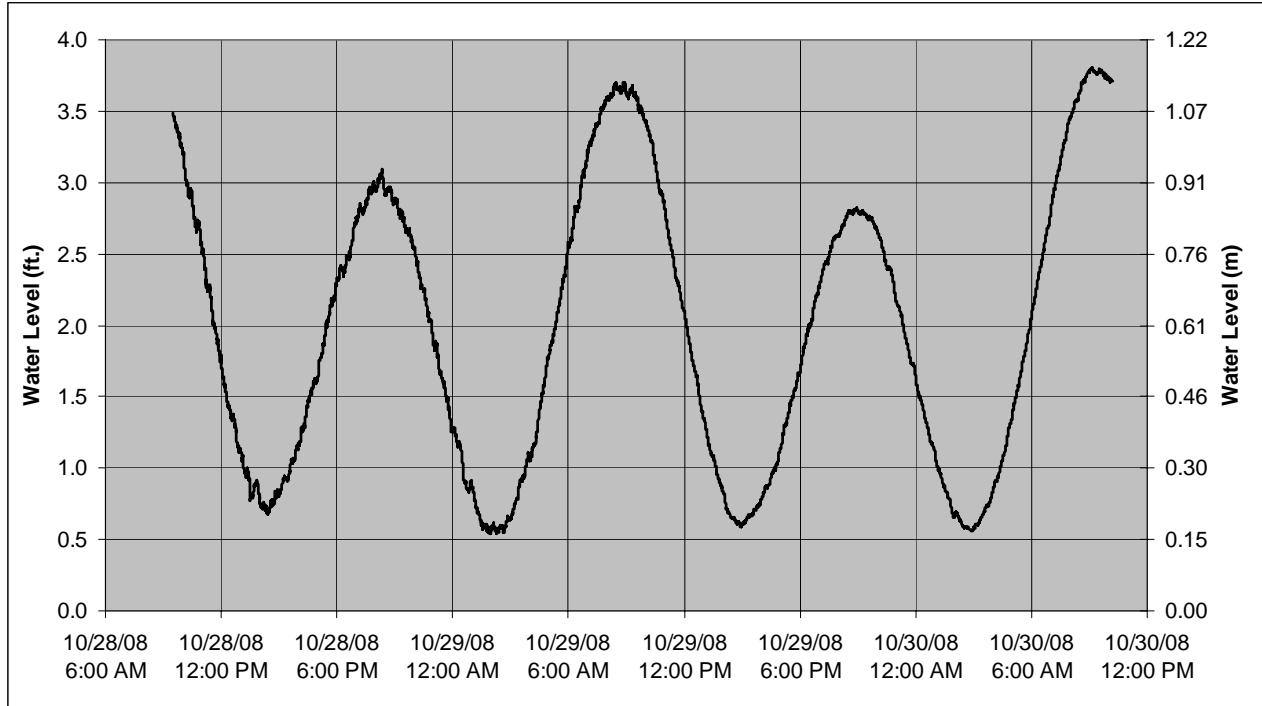
Current measurements were undertaken on October 28th and 29th, 2008 in order to gain insight to the typical tidal currents, as well as the effect of wind and waves on currents around Arawak Cay. Conditions on the 28th involved strong northwesterly winds, while the 29th was much calmer and more typical of conditions in the area. The wind conditions on the 28th were unusual, in that winds over 10 m/s from the NW quadrant occur only about one percent of the time. Tides during the sampling, shown in Figure 2.3, were mid-range in terms of magnitude and are approximately equal to mean tides at the site. The tide range was slightly higher in the morning compared to the evening on these particular days.

Figure 2.3 Tides at Nassau During the Current Measurements

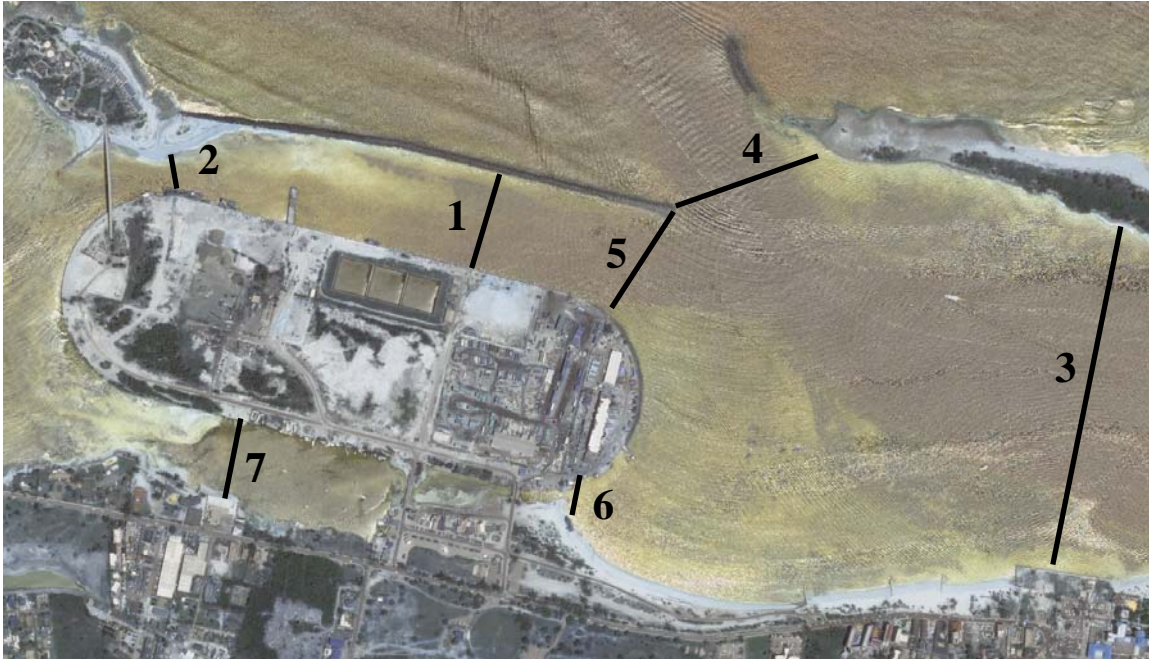
Figure 2.4 shows the approximate locations of the current measurement transects, as well as reference numbers for each repeatable transect.

Figure 2.4 Study Area With Current Transect Reference Numbers

The findings from the current transect investigations provide insight as to where suspended sediment resulting from dredge operations in Nassau Harbour may travel. In general, tidal flood (rising tide) causes movement of water from the west to the east. Conversely, ebb (falling) tide moves the water volume from the east to the west. It was shown from the field measurements that the total peak flow rate during the tidal cycle for the area between the mainland and Paradise Island is approximately $900 \text{ m}^3/\text{s}$. The majority of this tidal flow enters and exits through the harbour mouth (via the dredged navigation channel), whereas a smaller fraction of the flow passes between the west breakwater and Arawak Cay. In addition, a very small amount of the flow passes through the small boat channel to the south of Arawak Cay.

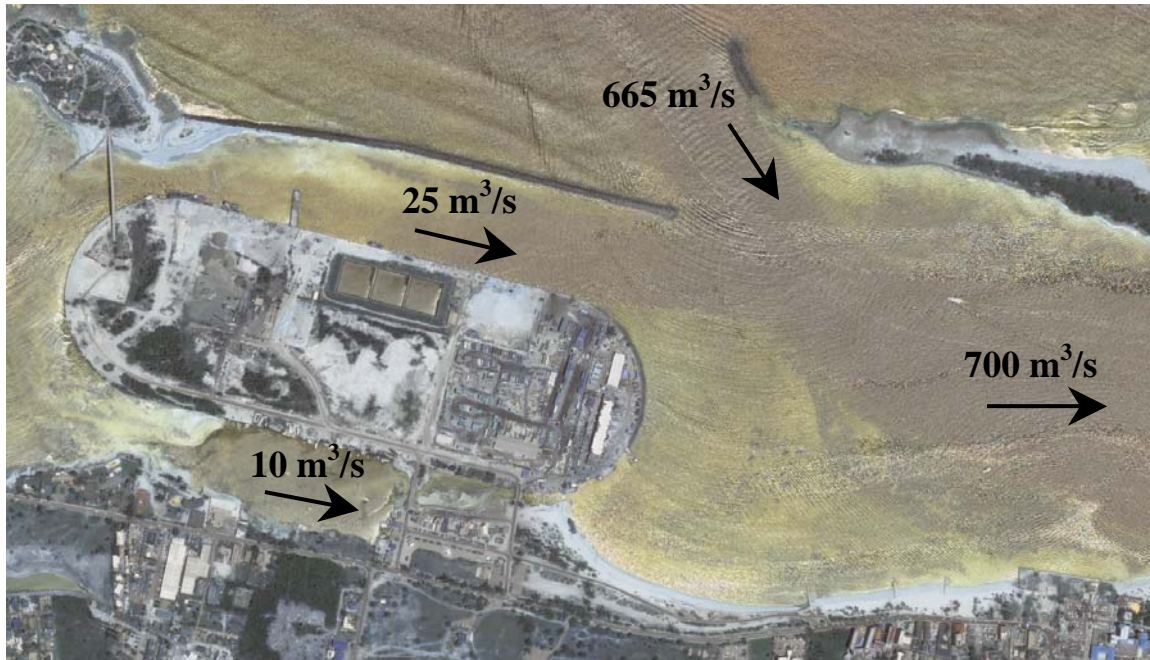
As previously described, the general direction of the baseline tidal flood discharge is from west to east. The data collected from the two days of current measurements was reduced in order to yield a general continuity plot around Arawak Cay (Figure 2.5). Due to the inability of the field program to record at each transect continuously at the same time, the flow rates indicated in this figure are best estimates of discharge at each of the sampling locations, based upon the measured data.

Figure 2.5 Generalized Ambient Flood Tide Measurements

Most of the tidal flood flow enters Nassau harbour through the harbour mouth, between the east and west breakwaters. This region has a channel cross section of about 3250 m², and typical current velocities of about 0.20 m/s. In the main part of harbour, the larger cross section means that the current velocities are lower than they are in the entrance, at about 0.10 m/s. These velocities will increase as the channel cross section narrows further to the east.

A relatively small amount of flow passes through both the north and south channels adjacent to Arawak Cay, with velocities of about 0.02 m/s in the wider parts of the north channel, which increase to about 0.10 m/s in the narrower areas. Evidence from the bathymetry in this area suggests that under storm conditions the flows and current velocities are much higher in the narrow area and some scour occurs. The higher velocities driven by winds on October 28th (these strong NW winds are a relatively rare occurrence at only about one percent of the time) resulted in currents at transect 2 that were in the order of 0.5 m/s. Current velocities in the south channel were also very weak, at about 0.02 to 0.04 m/s. In the shallow water of this channel, wind may well be the dominant factor in determining the current velocities.

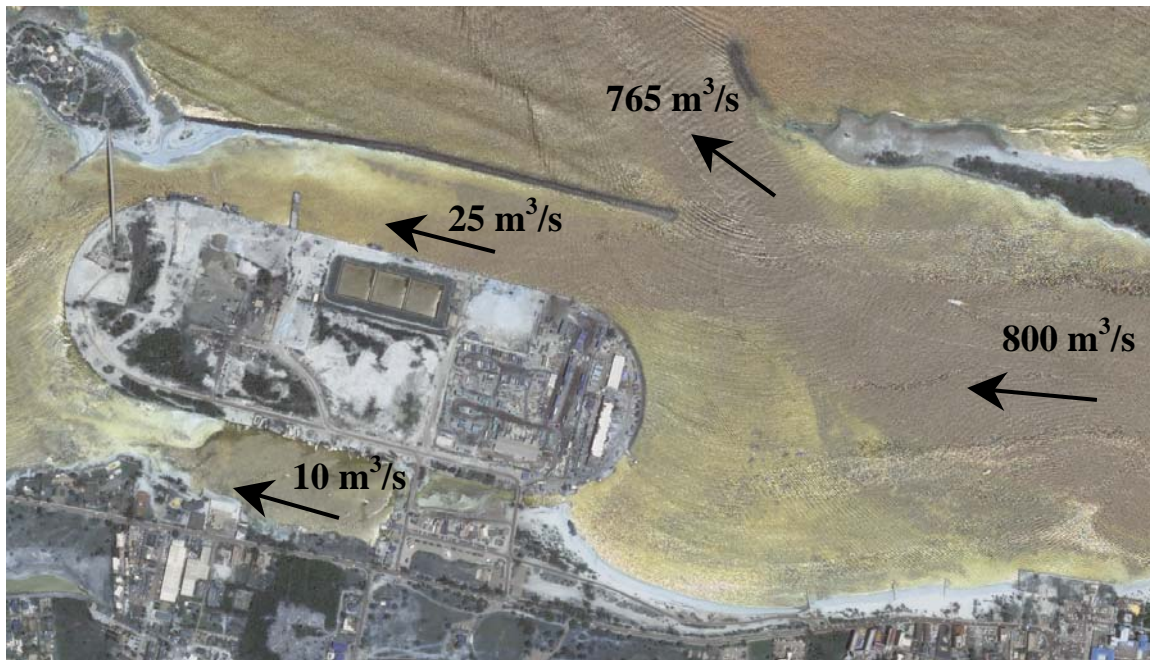
The ambient ebb tide in Nassau Harbour drives water from the east to the west. This flow direction would be of primary concern relating to the development of a suspended sediment control strategy to mitigate the introduction of dredge sediment to the area west of Arawak Cay. Similar to the results shown from the flood tide data, the majority of the water volume exchanged from Nassau Harbour passes out of the mouth of the harbour, between the east and west breakwaters. Figure 2.6 shows the approximate peak discharge values for a baseline ebb tide condition. Similar to the flood tide values presented above, these estimated discharge values were based upon collected data during field exercises.

Figure 2.6 Generalized Ambient Ebb Tide Measurements

This schematic representation shows that less than 5% of the total flow passing through the harbour enters either of the channels that pass north or south of Arawak Cay. Despite the fact that this is only a small portion of the water passing through the harbour, it still represents a significant total volume of water over the duration of the tidal cycle.

Flows from the east through the harbour area appear to be marginally stronger than the opposing flood tide, perhaps due to the prevailing east winds. Currents velocities in the main harbour area are in the order of 0.10 m/s as a average cross sectional velocity.

Field observations indicate that the change in direction of tidal current is fairly abrupt, and that the currents are fairly uniform throughout the ebb. Therefore to assess the total volume of water passing to the west of Arawak Cay, the nominal flow rate from Figure 2.6 is applied over six hours (the approximate duration of a semi-diurnal ebb tide). This results in about 750,000 m³ of water entering the region west of Arawak Cay. With an average depth of about 3 m, this volume of water could completely fill an area with a surface area of 250,000 m². This might be (for example) an area of 500 m by 500 m in size, as shown in Figure 3.1. The shape and extent of the region that is affected will certainly not be as indicated in this figure; this figure is intended to provide a representation of scale.

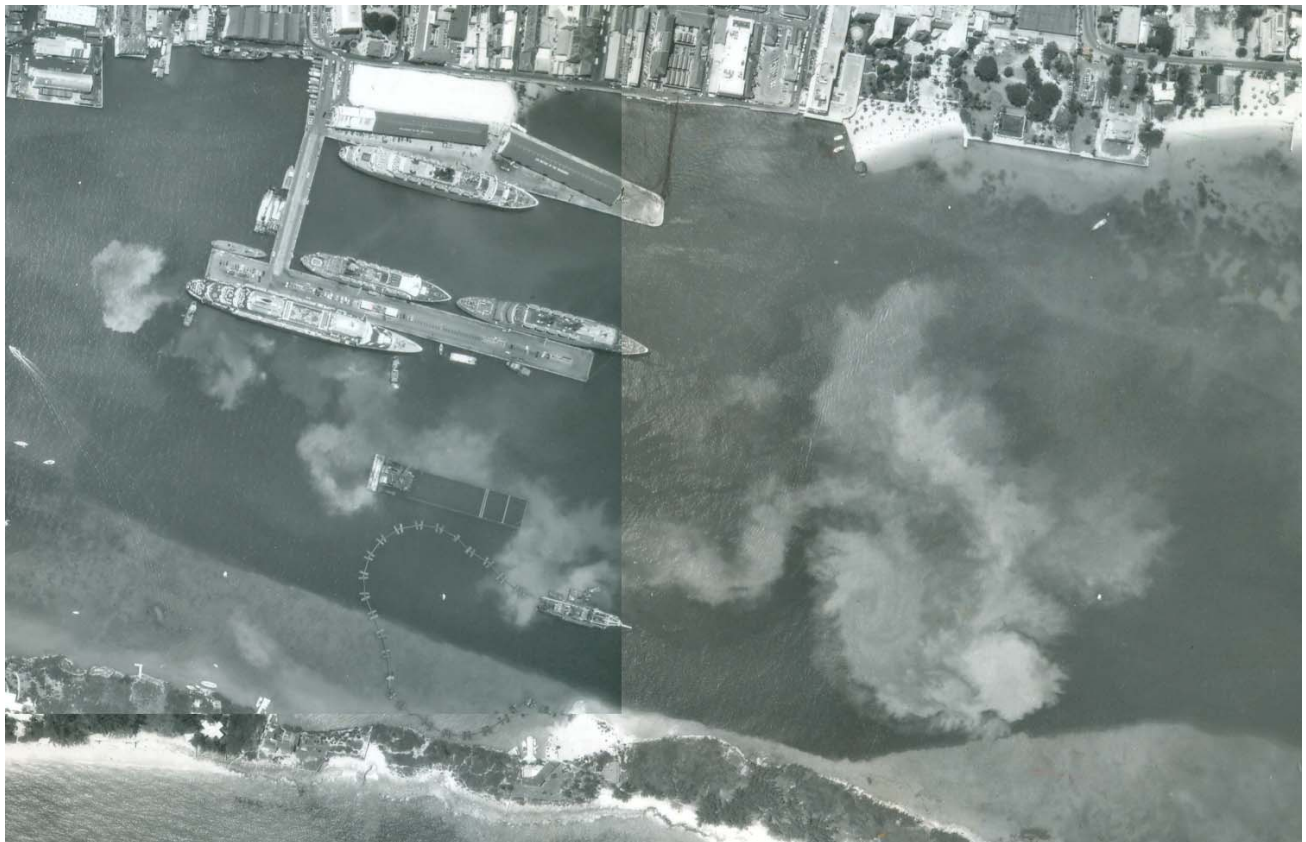
- The turbidity levels east of Arawak Cay are presently undefined.
- The distribution of turbidity east of Arawak Cay is also important. The location where the dredger is operating may create conditions where the most turbid water is far from Arawak Cay, or perhaps very close the north channel. Figure 3.2 provides an aerial view of a dredging plume from 1989, which shows a large amount of spatial variability.

Figure 3.2 Example of a Dredging Plume from 1989 Aerial Photograph

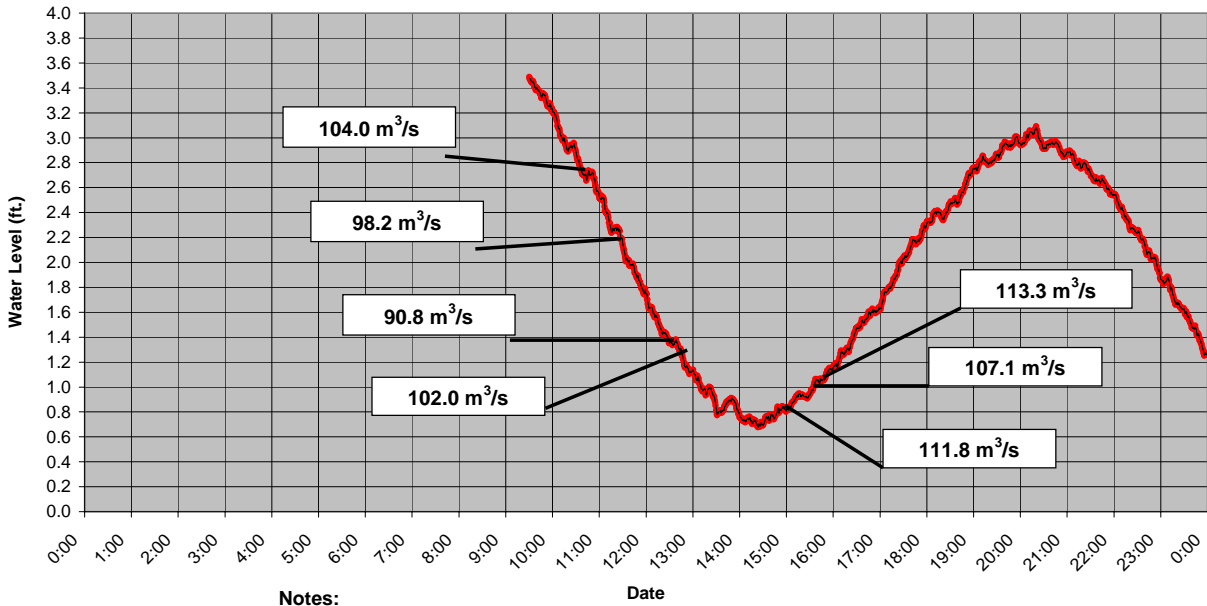
Recorded Discharge Values for Transects 1 and 2 - October 28th, 2008

- (1) Tides reduced to MLWS;
- (2) Positive discharge values denote flow from west to east;
- (3) Channel cross-section was approximately 1275 m² for Transect 1;
- (4) Channel cross-section was approximately 310 m² for Transect 2;
- (5) Strong NNE wind present during measurements on October 28th, 2008.

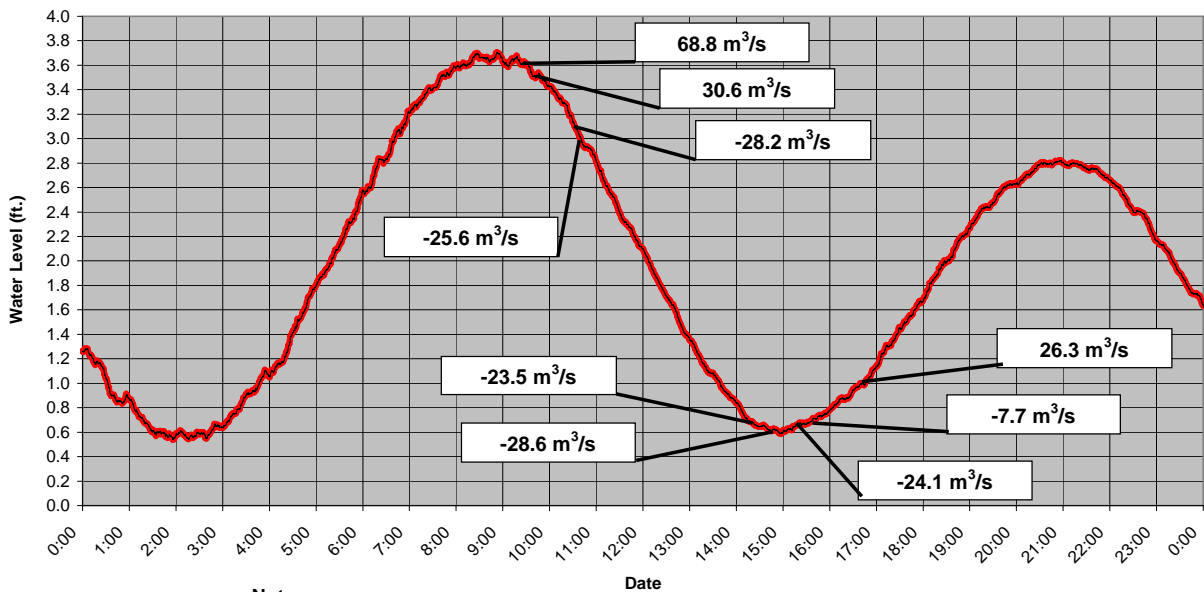
Recorded Discharge Values for Transects 1 and 2 - October 29th, 2008

- (1) Tides reduced to MLWS;
- (2) Positive discharge values denote flow from west to east;
- (3) Channel cross-section was approximately 1275 m² for Transect 1;
- (4) Channel cross-section was approximately 310 m² for Transect 2;
- (5) Mild NNW wind present during measurements on October 29th, 2008.

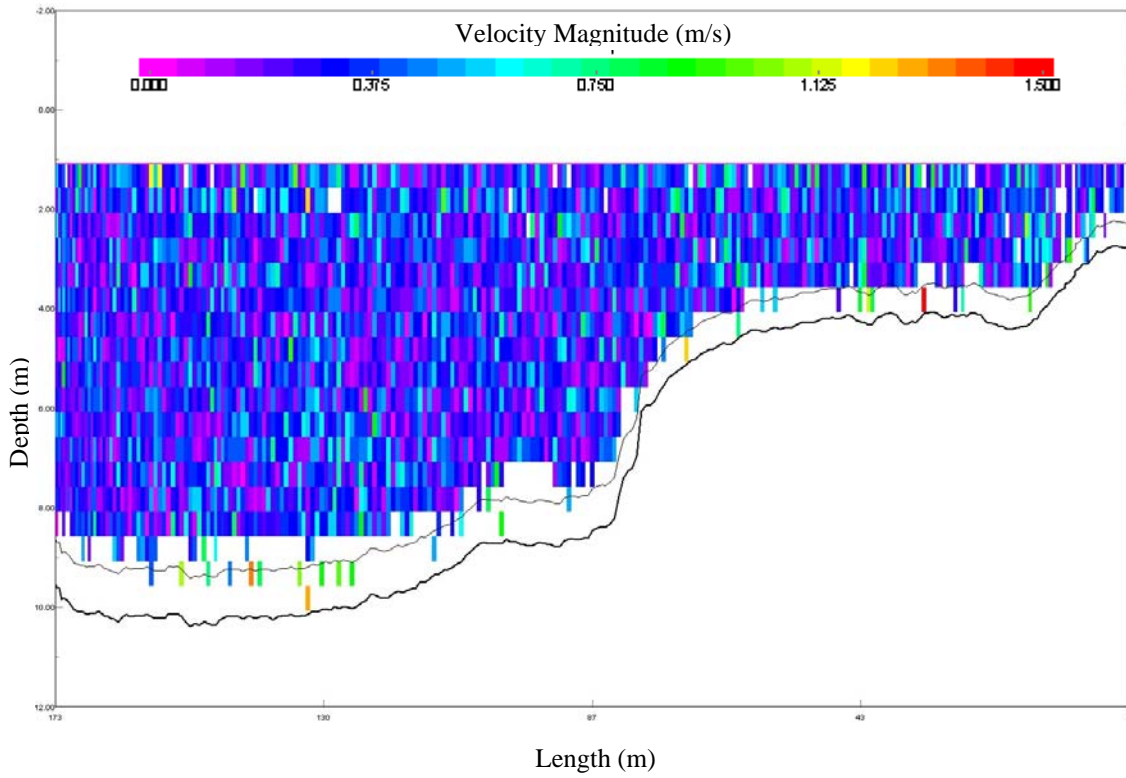
Sample Current Profile for Channel Transect 1 During Ebb Tide, October 28th, 2008

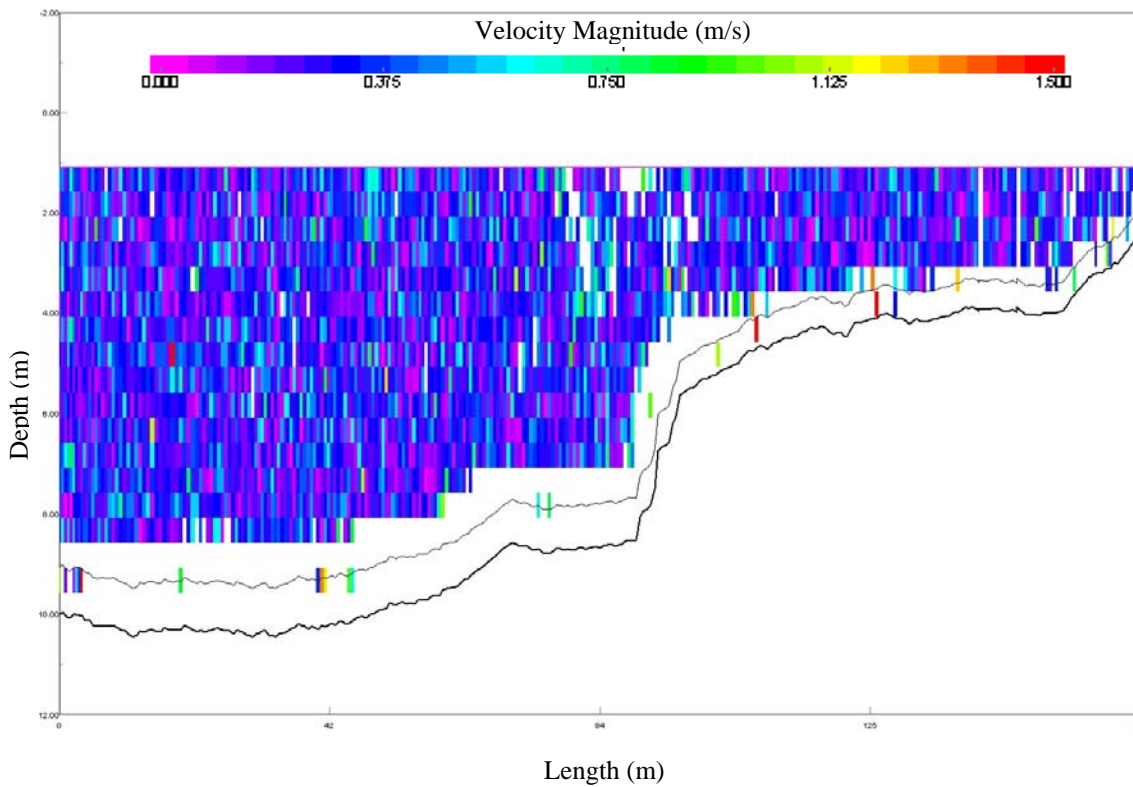
Sample Current Profile for Channel Transect 1 During Flood Tide, October 29th, 2008

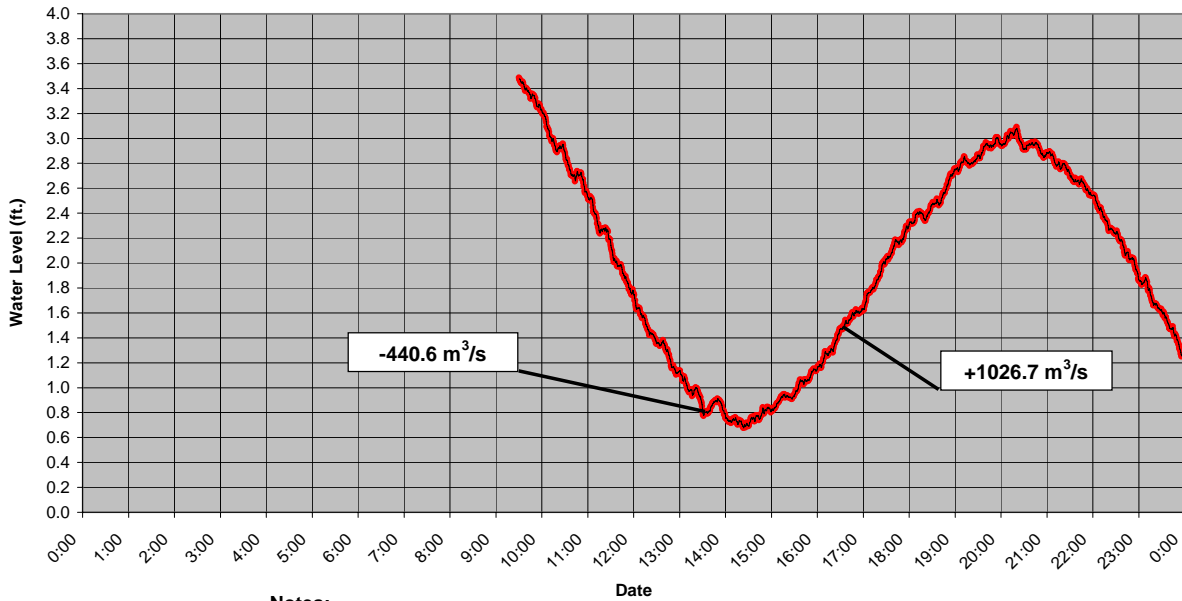
Recorded Discharge Values for Transect 3 - October 28th, 2008

- (1) Tides reduced to MLWS;
- (2) Positive discharge values denote flow from west to east;
- (3) Channel cross-section was approximately 6100 m² for Transect 3;
- (4) Strong NNE wind present during measurements on October 28th, 2008.

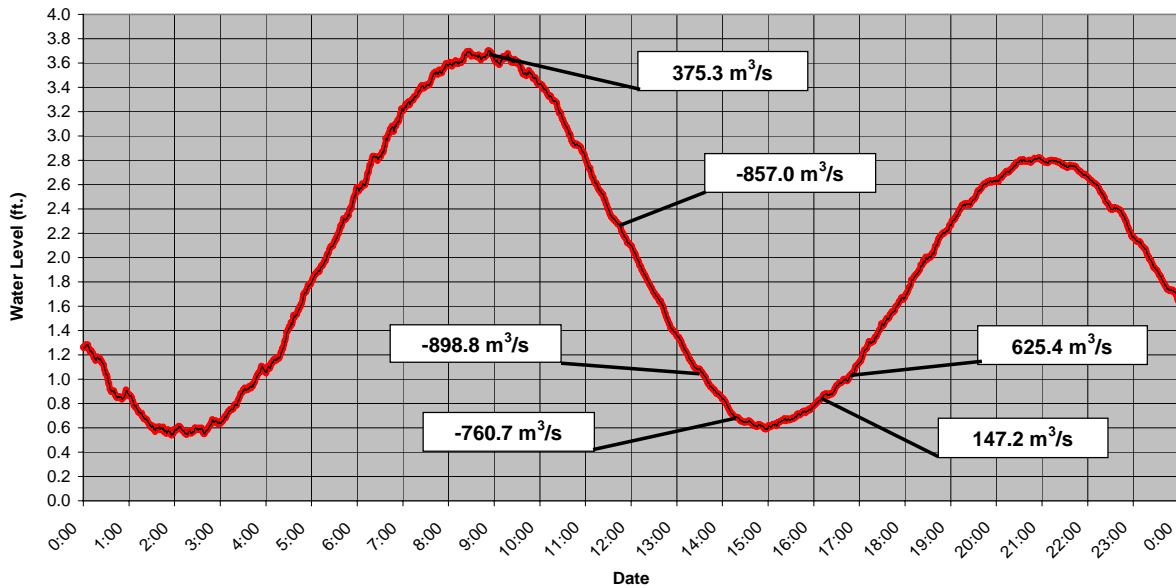
Recorded Discharge Values for Transect 3 - October 29th, 2008

- (1) Tides reduced to MLWS;
- (2) Positive discharge values denote flow from west to east;
- (3) Channel cross-section was approximately 6100 m² for Transect 3;
- (4) Mild NNW wind present during measurements on October 29th, 2008.

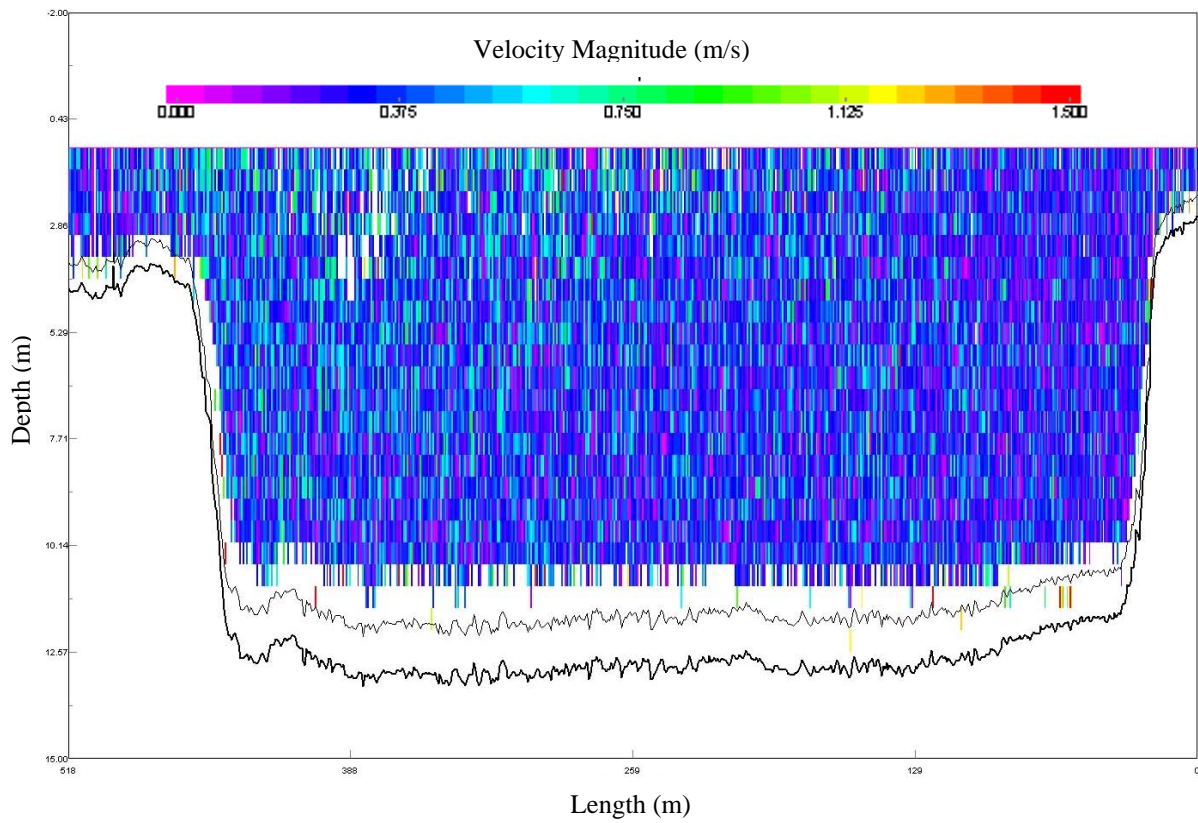
Sample Current Profile for Channel Transect 3 During Flood Tide, October 28th, 2008

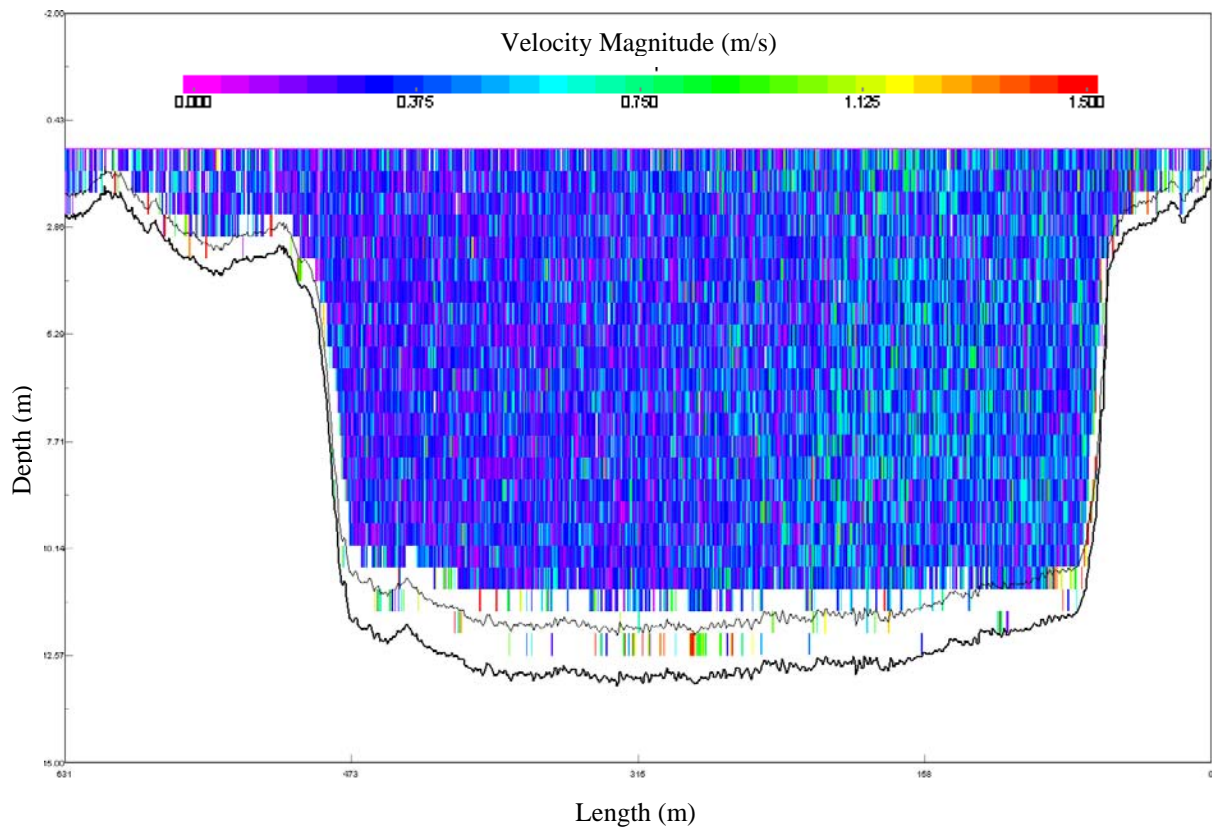
Sample Current Profile for Channel Transect 3 During Ebb Tide, October 29th, 2008

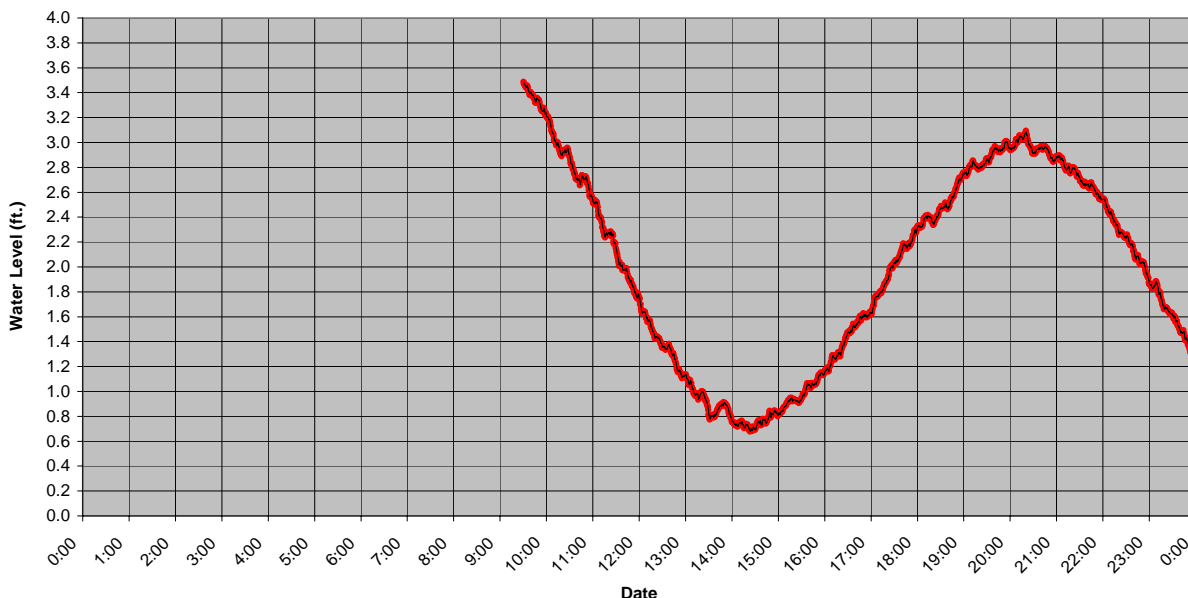
Recorded Discharge Values for Transect 4 - October 28th, 2008

- (1) No data taken on October 28th due to strong NNE wind present during measurements;
- (2) Tides reduced to MLWS;
- (3) Positive discharge values denote flow from west to east;
- (4) Channel cross-section was approximately 3250 m² for Transect 4.

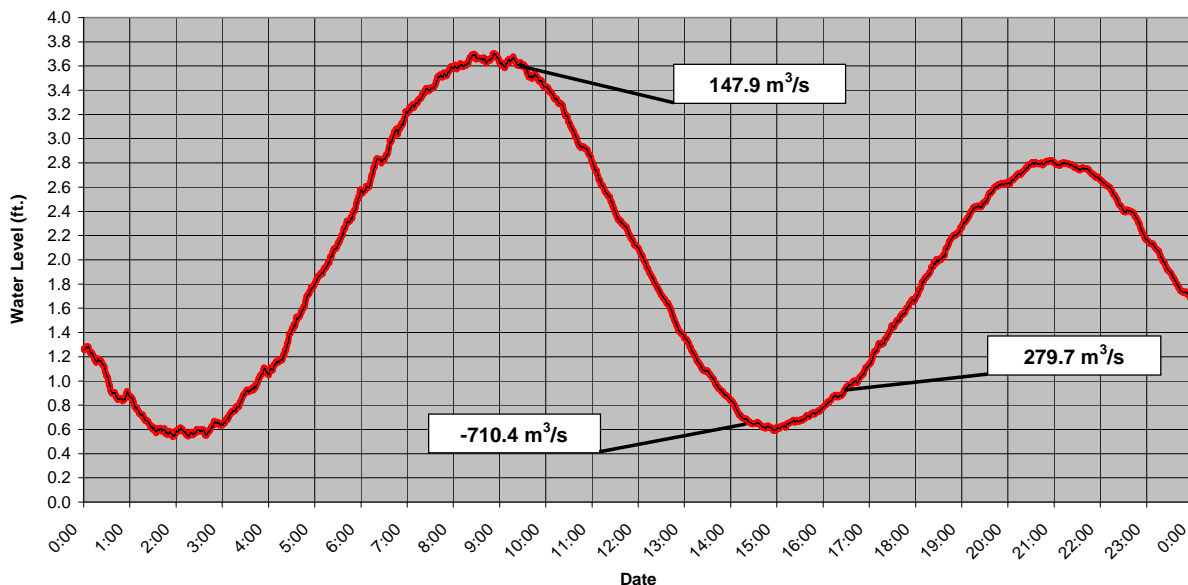
Recorded Discharge Values for Transect 4 - October 29th, 2008

- (1) Tides reduced to MLWS;
- (2) Positive discharge values denote flow from west to east;
- (3) Channel cross-section was approximately 3250 m² for Transect 4;
- (4) Mild NNW wind present during measurements on October 29th, 2008.

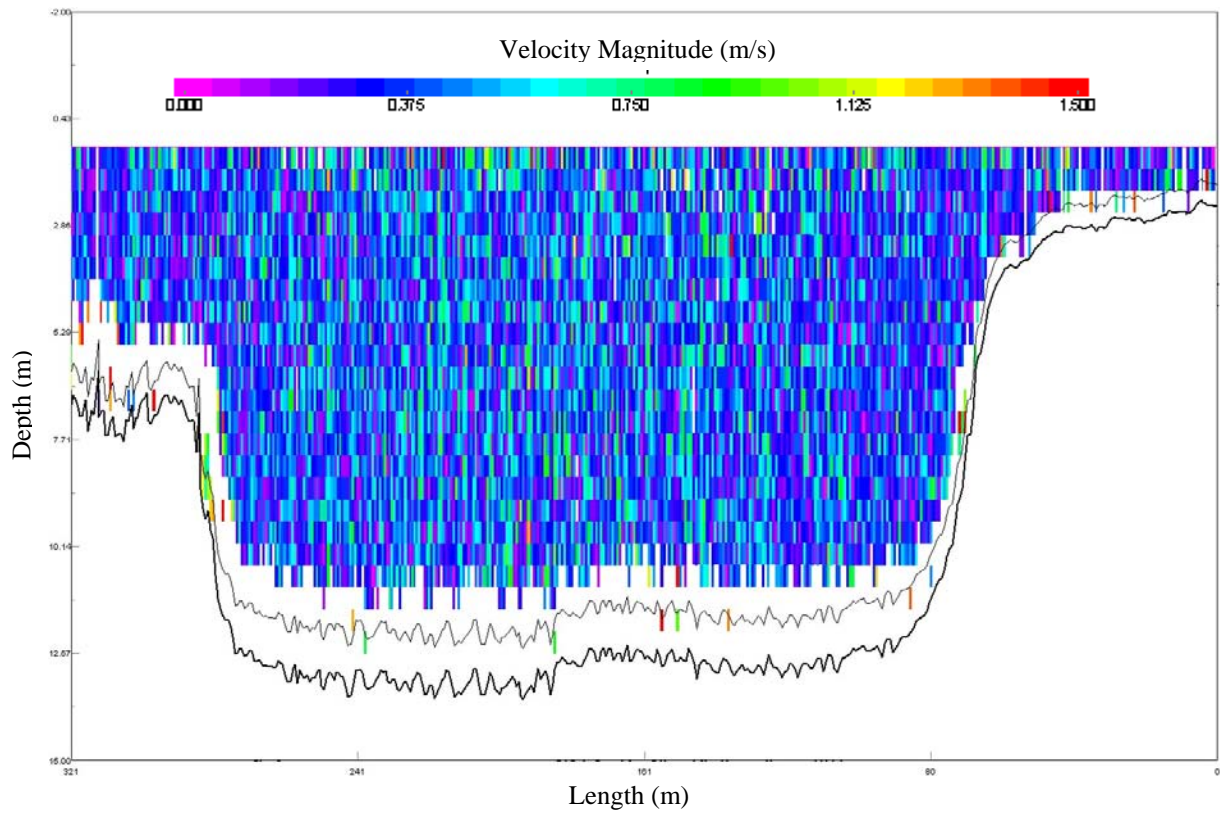
Sample Current Profile for Channel Transect 4 During Ebb Tide, October 29th, 2008

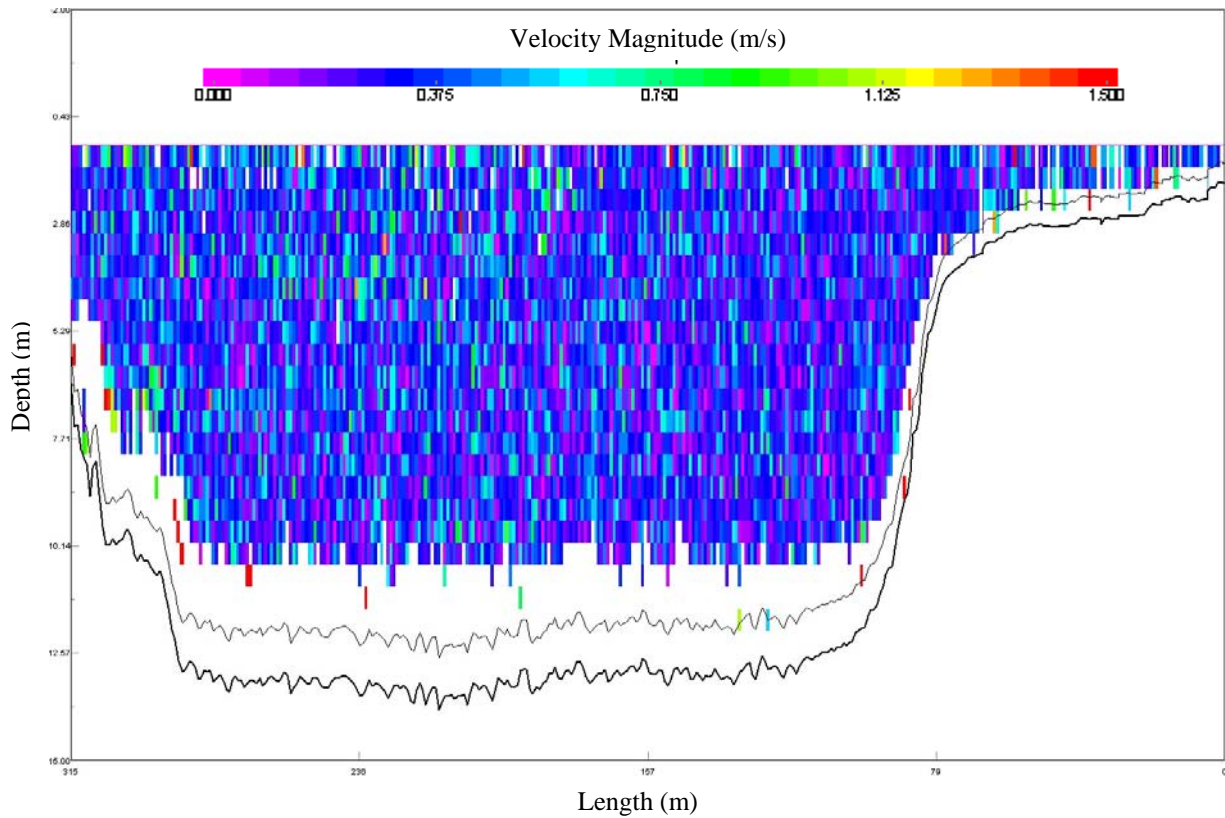
Sample Current Profile for Channel Transect 4 During Flood Tide, October 29th, 2008

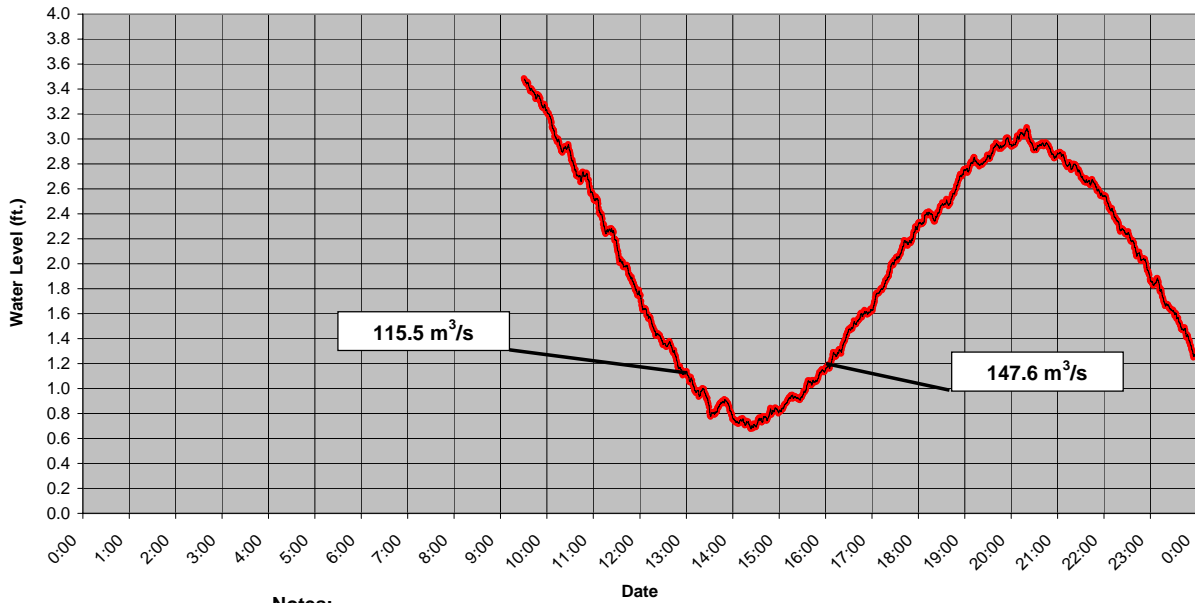
Recorded Discharge Values for Transect 5 - October 28th, 2008

- (1) Tides reduced to MLWS;
- (2) Positive discharge values denote flow from west to east;
- (3) Channel cross-section was approximately 1825 m² for Transect 5;
- (4) Strong NNE wind present during measurements on October 28th, 2008.

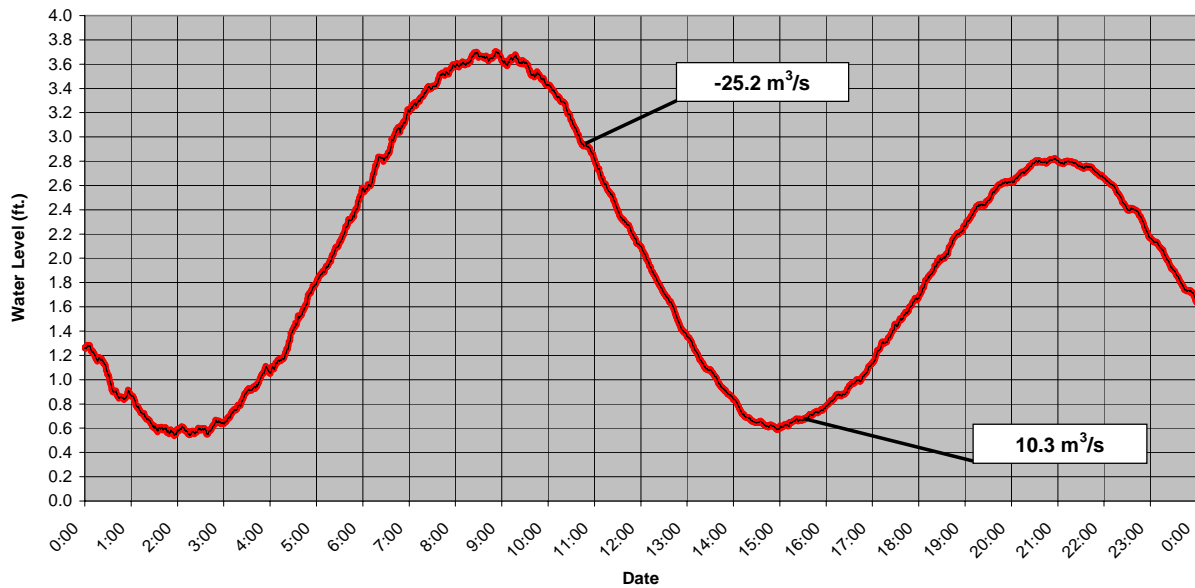
Recorded Discharge Values for Transect 5 - October 29th, 2008

- (1) Tides reduced to MLWS;
- (2) Positive discharge values denote flow from west to east;
- (3) Channel cross-section was approximately 1825 m² for Transect 5;
- (4) Mild NNW wind present during measurements on October 29th, 2008.

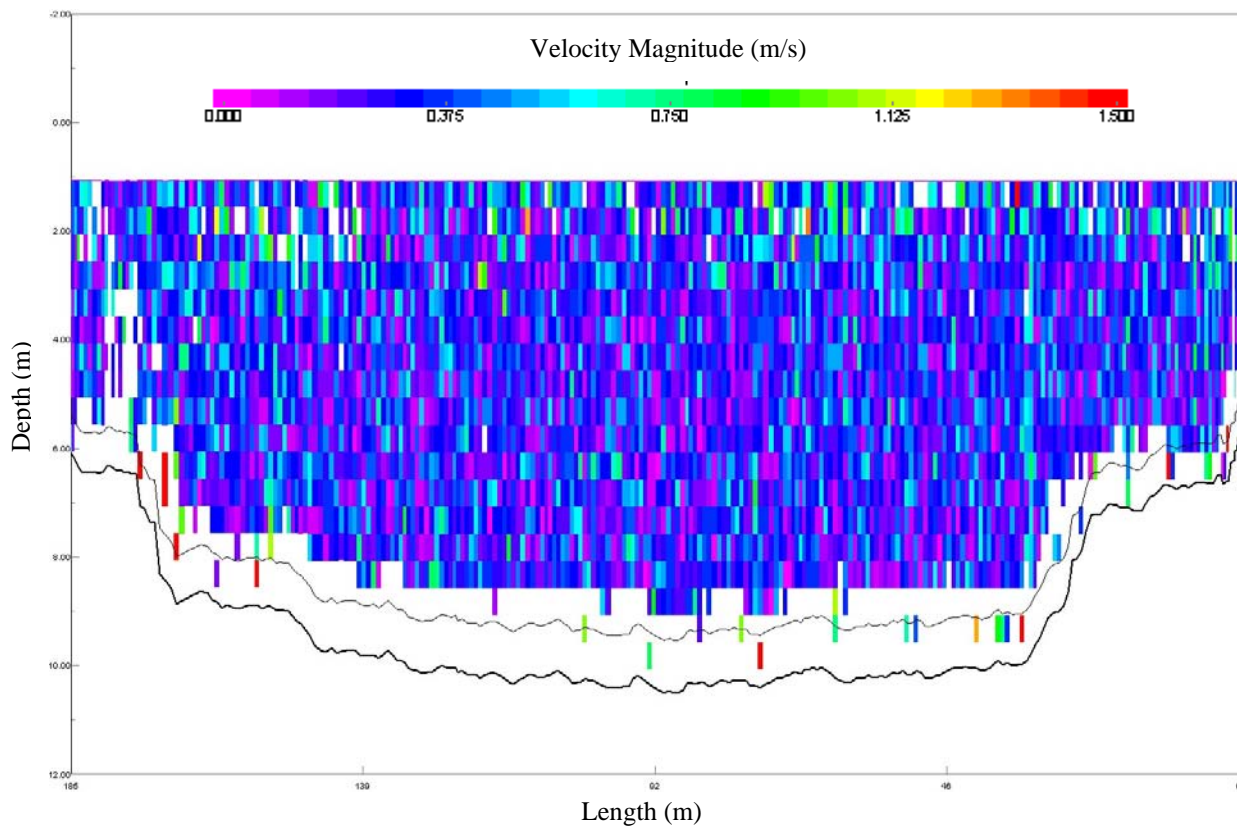
Sample Current Profile for Channel Transect 5 During Flood Tide, October 28th, 2008
