Currents in Nassau Harbour **Nassau Harbour Port Improvement Project**

Currents in Nassau Harbour

Nassau Harbour Port Improvement Project

Draft Report

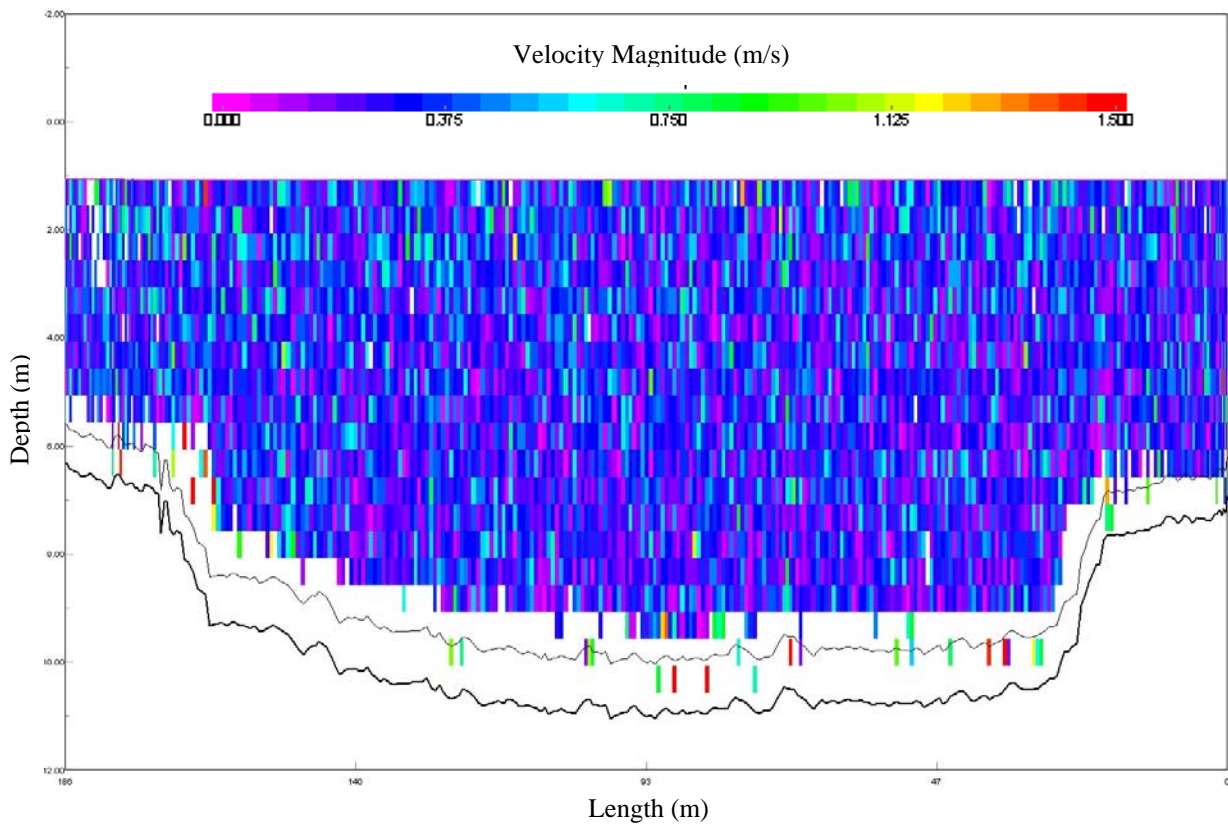
Sample Current Profile for Channel Transect 5 During Ebb Tide, October 29th, 2008
